# Concrete Repair

A practical guide

Edited by Michael G. Grantham

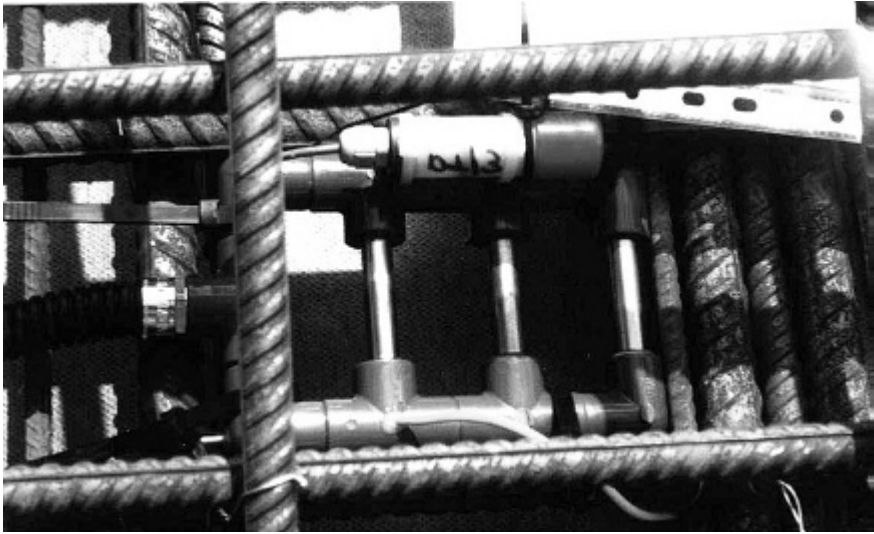
*Figure 7.1* A permanent LPR monitoring probe being installed in a precast deck unit of the Dartford Tunnel (Broomfield et al. 2003) (photograph courtesy BGB Projects Ltd).

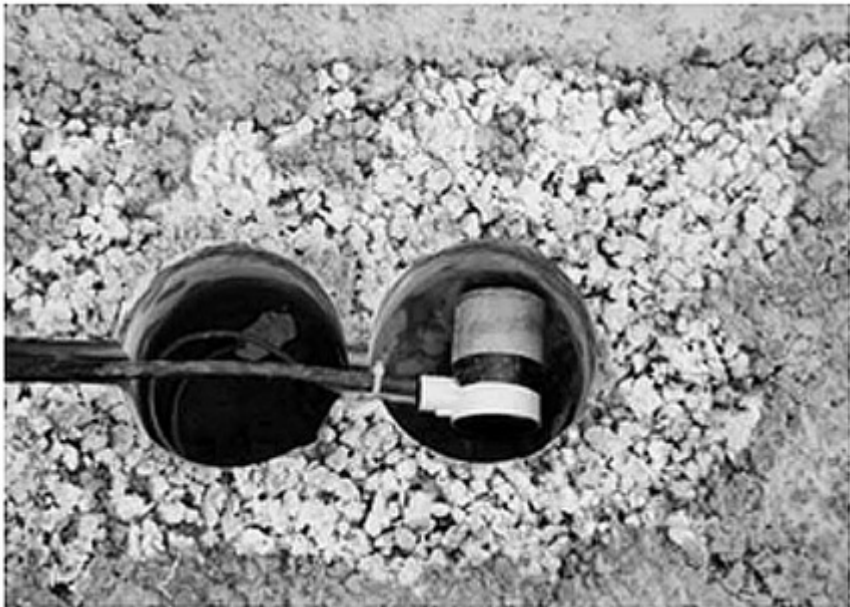
*Figure 7.2* A corrosion monitoring probe consisting of a reference electrode and an auxiliary electrode potted up in mortar in the process of installation into a continuously reinforced concrete pavement where corrosion monitoring is required due to the high level of chloride found in the mix water after laying several kilometres of concrete (Broomfield et al. 2003) (photograph courtesy BGB Projects Ltd).

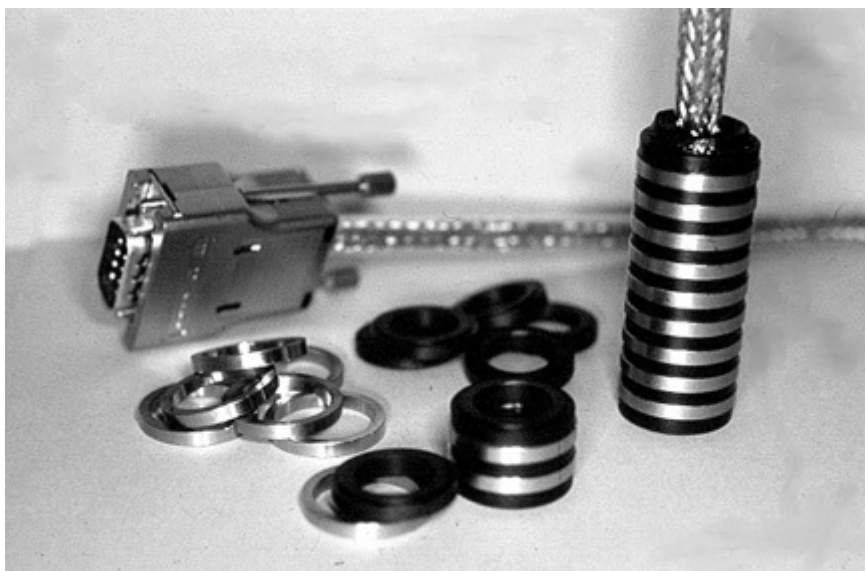
*Figure 7.5* Galvanic 'washer' probe (Raupach and Schiessl 1995). The assembly is fitted into a cored hole in the concrete cover so that successive washers depassivate and a galvanic current starts to flow between the anode and a noble metal cathode (photograph courtesy Dr Ing. M. Raupach).

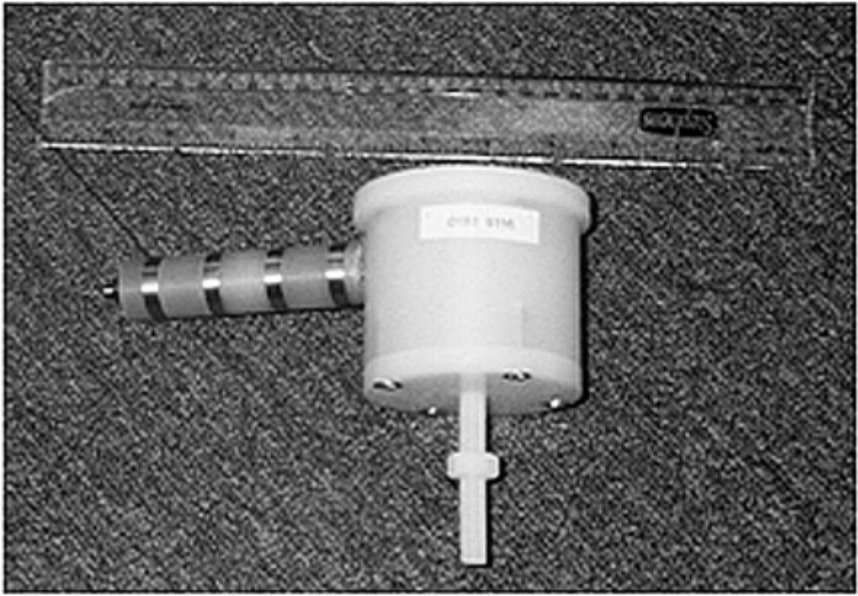
*Figure 7.6* This resistivity probe is directly attached to the formwork so that when the concrete is cast around it the four stainless steel washers can be used to make four probe resistivity measurements.

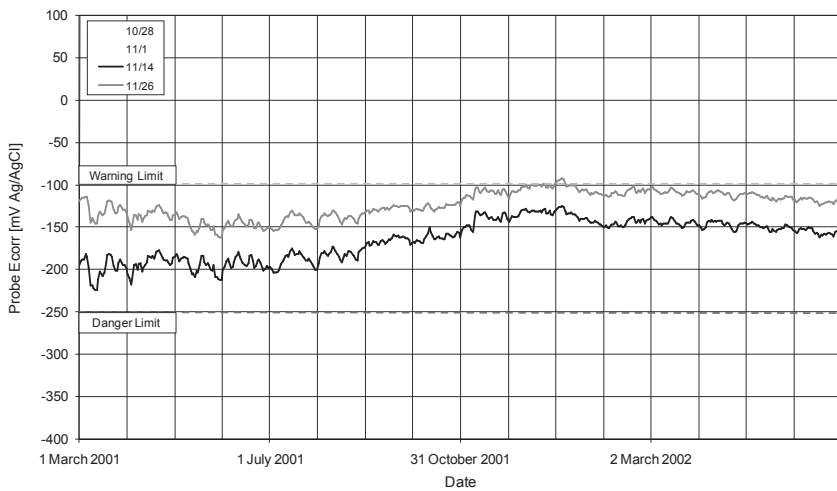
*Figure 7.7* Over three years of data from resistivity probes (Broomfield et al. 2003).

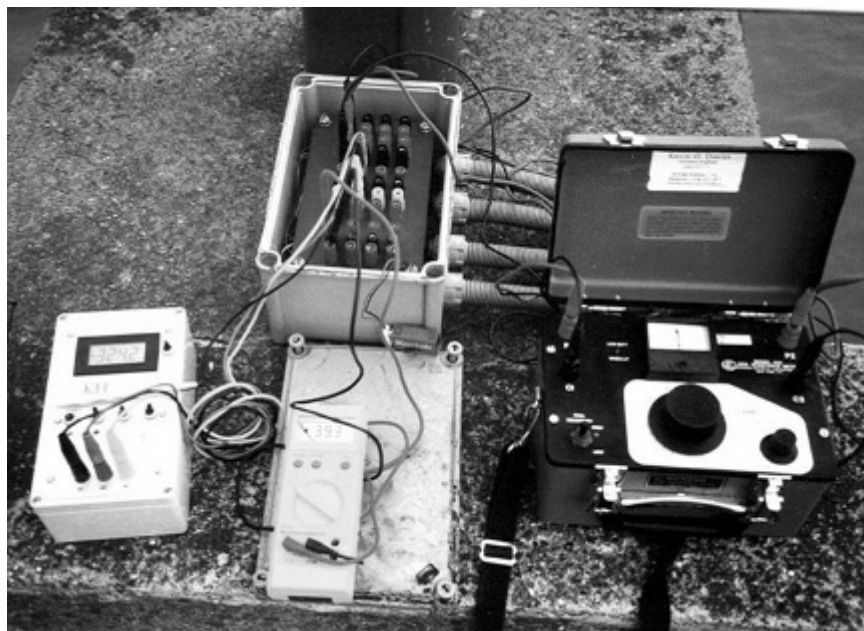
Figure 7.8 Termination box with connections for reference electrodes, LPR probes and resistivity probes on a jetty.

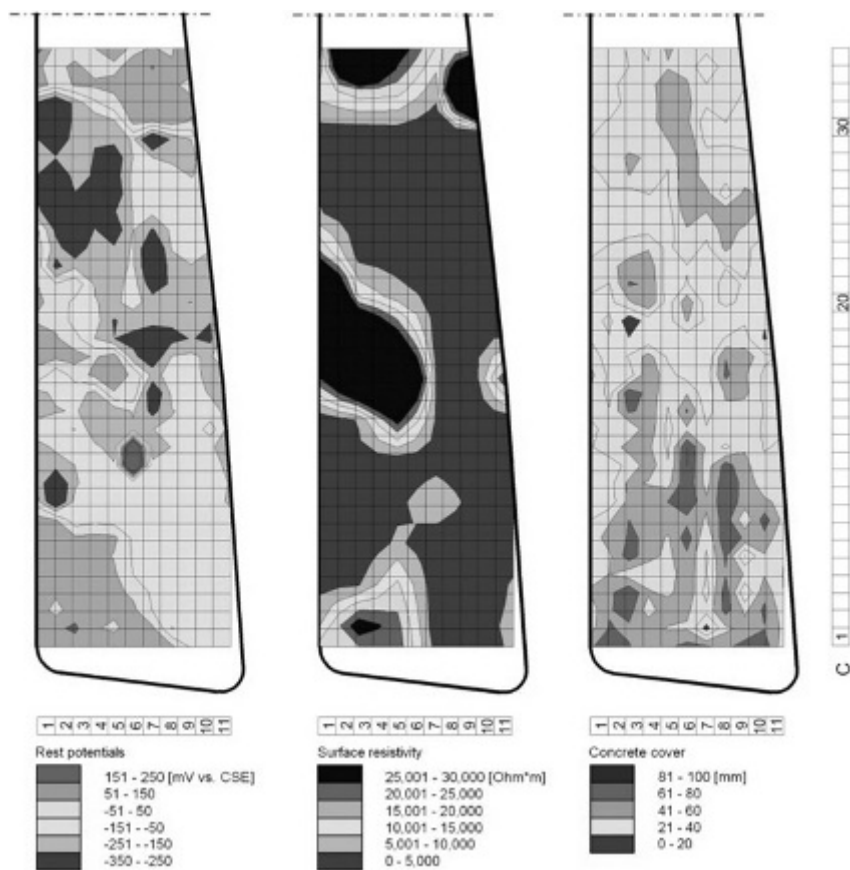
*Figure 8.5* Example for a combined data acquisition in a condition survey – rest potentials, surface resistivity readings and minimum concrete cover.

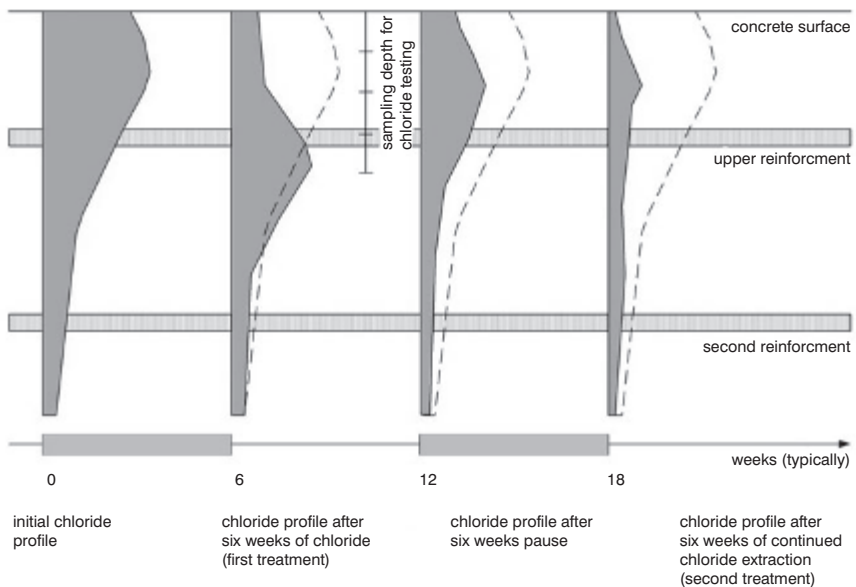
*Figure 8.6* Dynamics of chloride migration during a multi-stage ECE application at high chloride ingress depths and with more than one reinforcement layer.

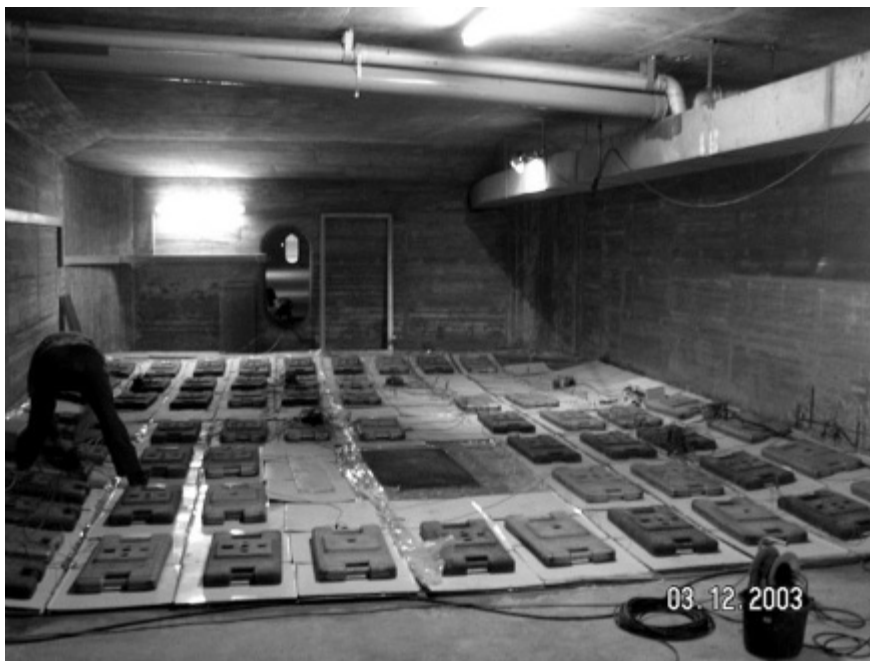
*Figure 8.7* Layout of the anodes for the ECE treatment of the hollow box girder floor slab.

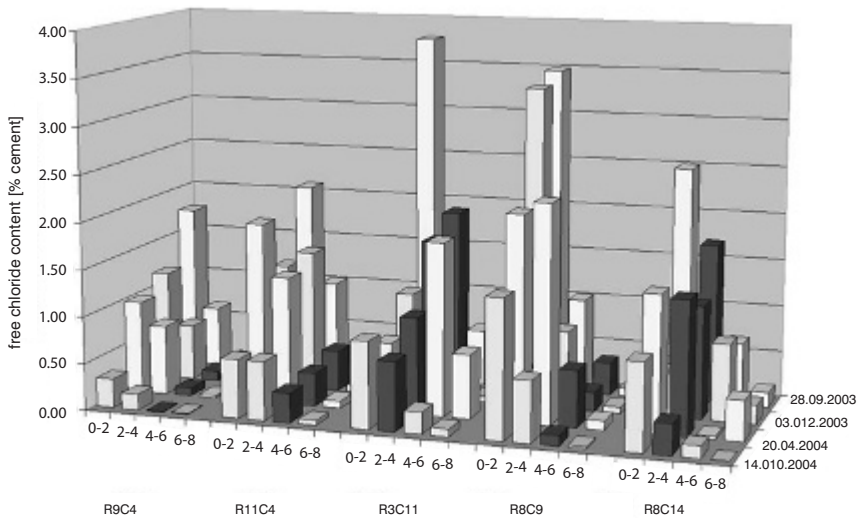
*Figure 8.8* Development of chloride profiles in formerly high chloride containing locations; dark bars show chloride content in the vicinity of the upper reinforcement.

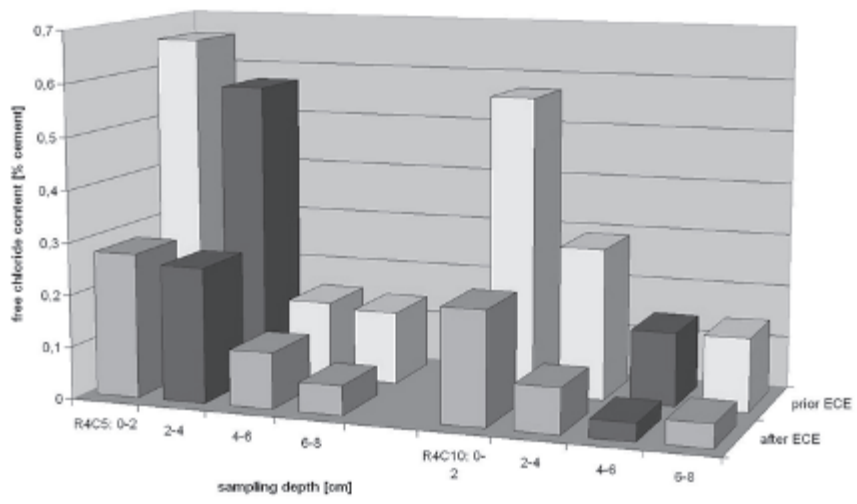
Figure 8.11 ECE effect from two sampling locations until 8 cm concrete depth (dark bars indicating reinforcement depth).

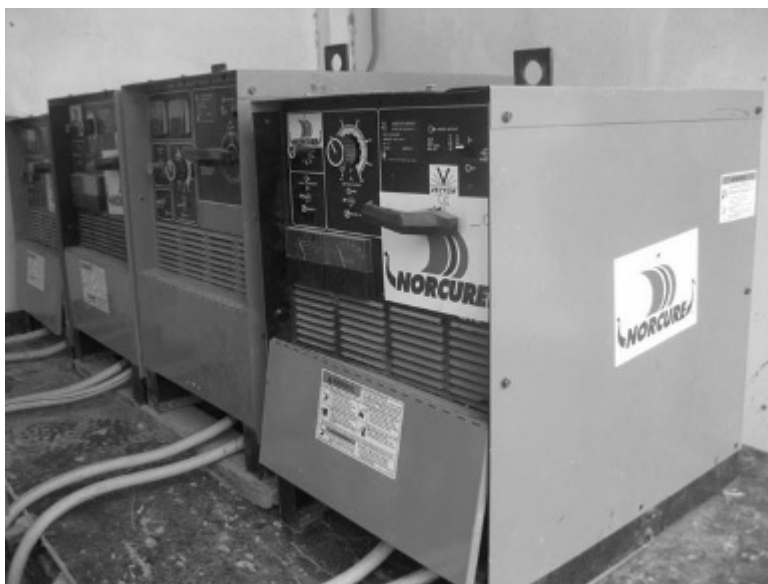
*Figure 9.1* Typical transformer rectifier used for electrochemical realkalisation and chloride removal (courtesy of Vector Corrosion Technologies).

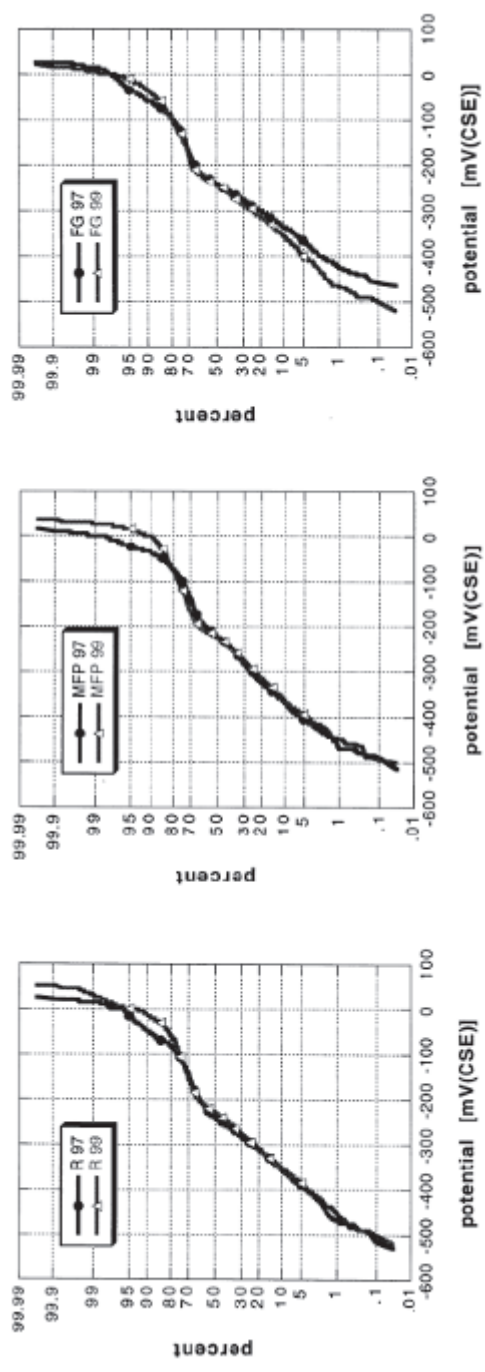
Figure 10.1 Behaviour of corrosion inhibitors (from Schiegg et al., 2000).

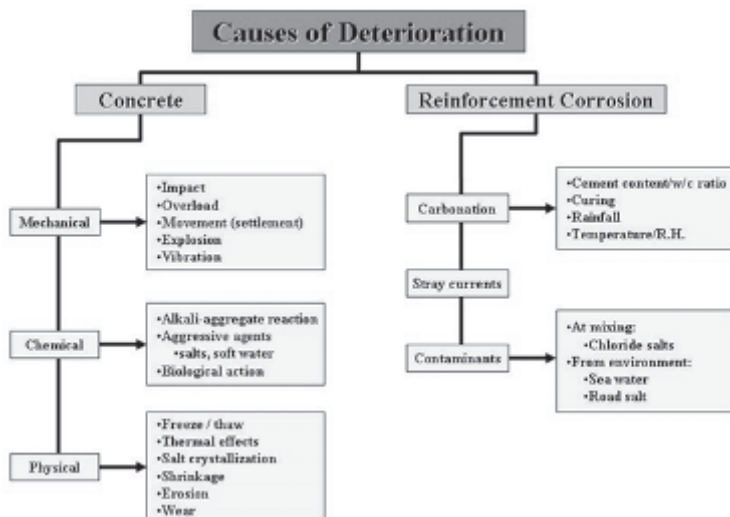
Figure 11.1 Common causes of concrete deterioration covered by EN 1504 methods

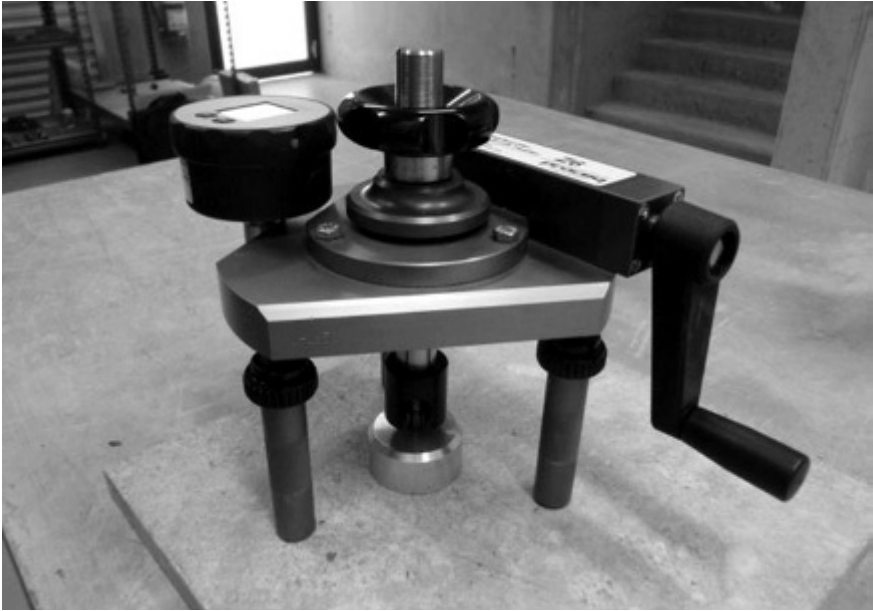
Figure 13.8 Typical pull-off tester (courtesy of Safe Environments, Australia).

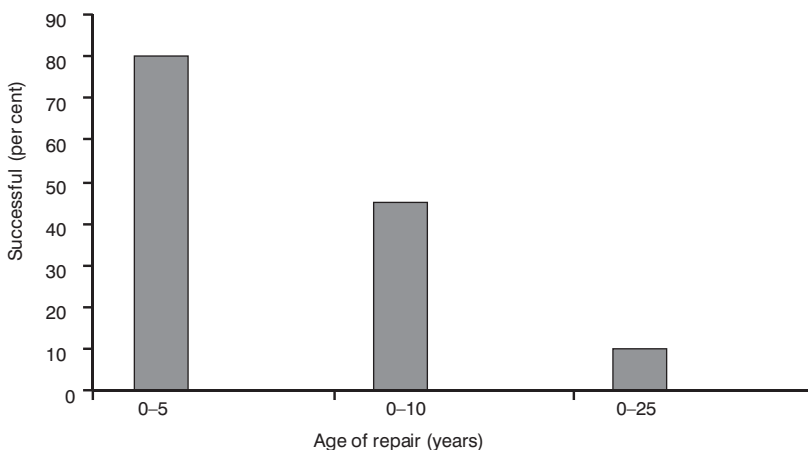
Figure 14.9 Performance in relation to age of repair.

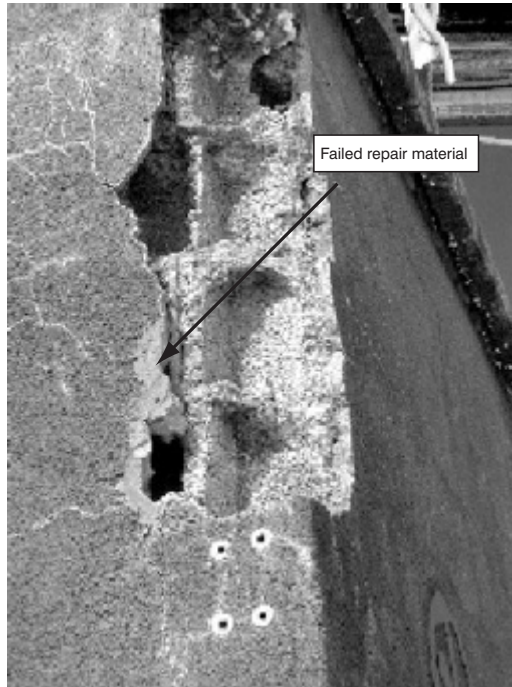
*Figure 14.14* Damaged concrete repaired with incorrect material.

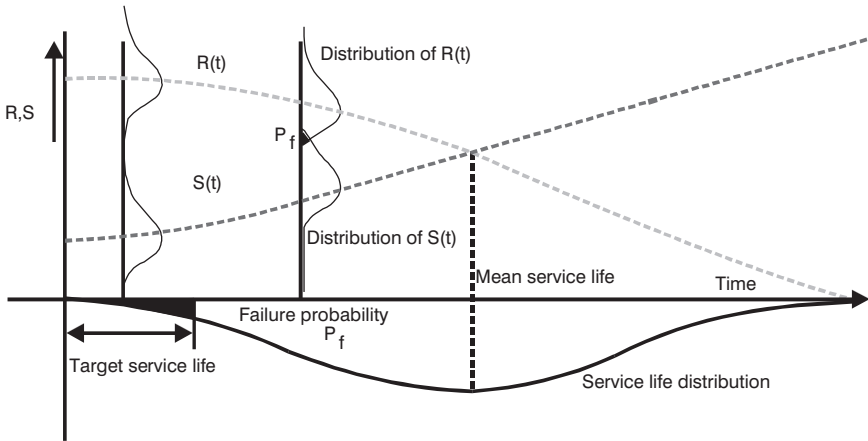
Figure 15.1 Schematic representation of probabilistic service-life design (Source: DuraCrete, 2000, Siemes et al., 2000).

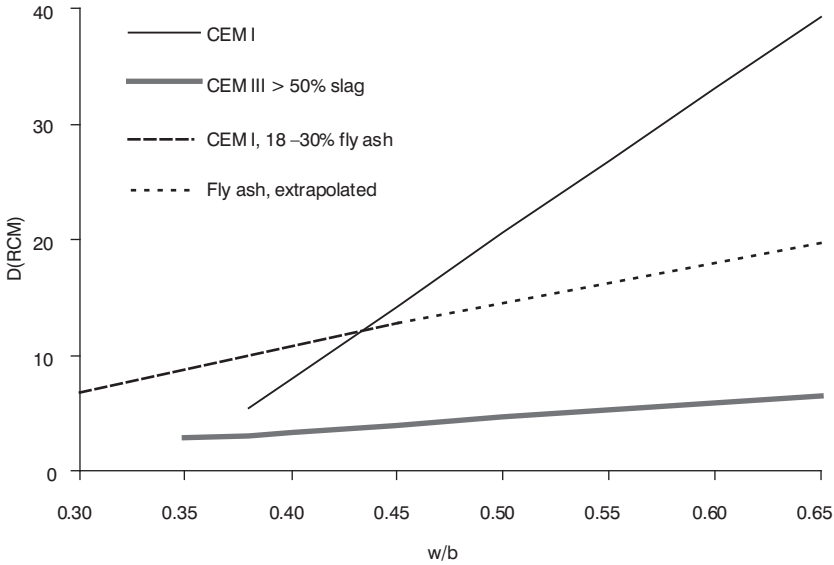
Figure 15.2 Correlation between  $w/b$  and  $D_{RCM}$  at about 28 days; all values\*  $10^{-12} \text{ m}^2/\text{s}$ .

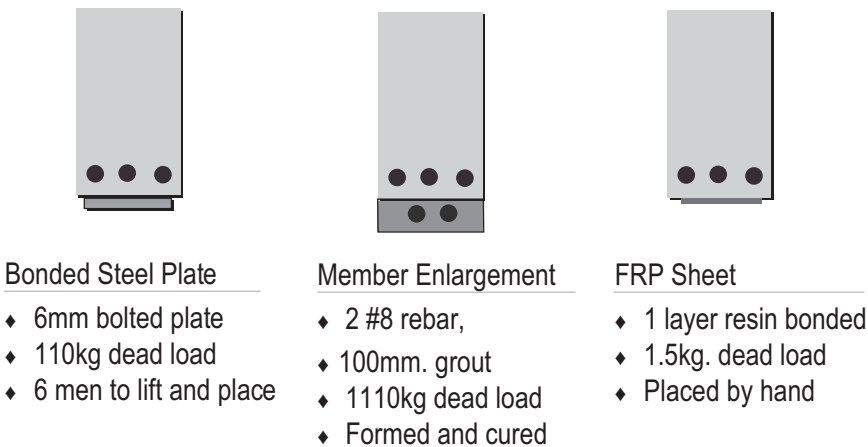
Figure 16.3 Methods of strengthening beams with FRP.

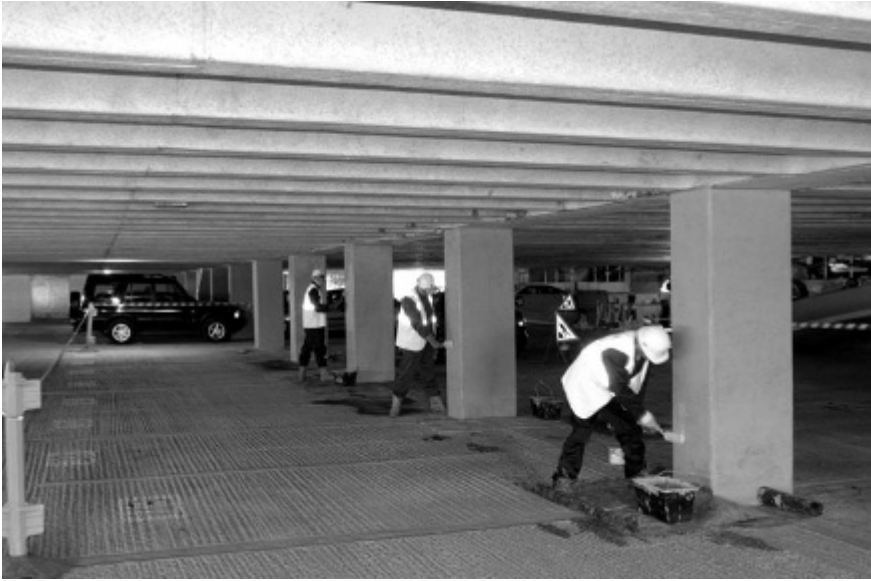
*Figure 16.4* Protection to the MBrace Kevlar using Masterseal 525 flexible cementitious coating.

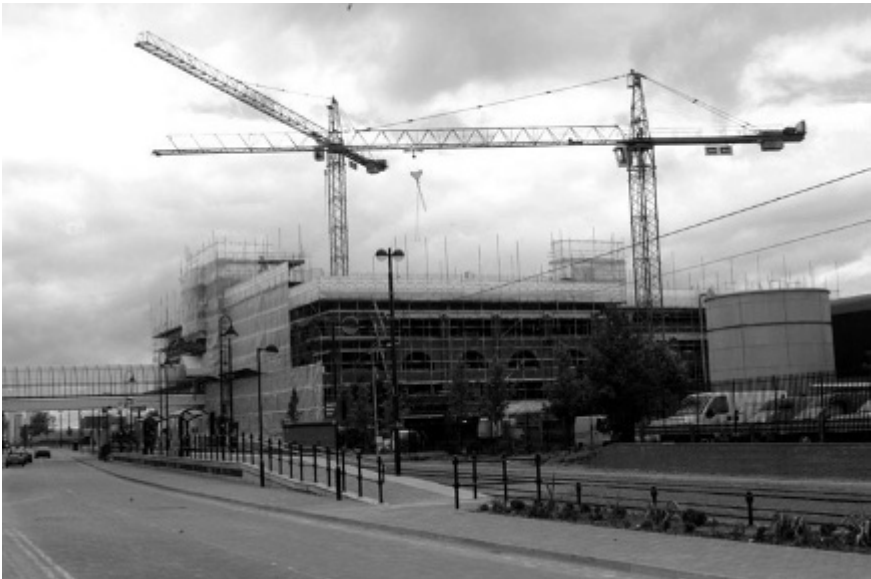
*Figure 16.5* Extra floors being added to the structure after Kevlar application.

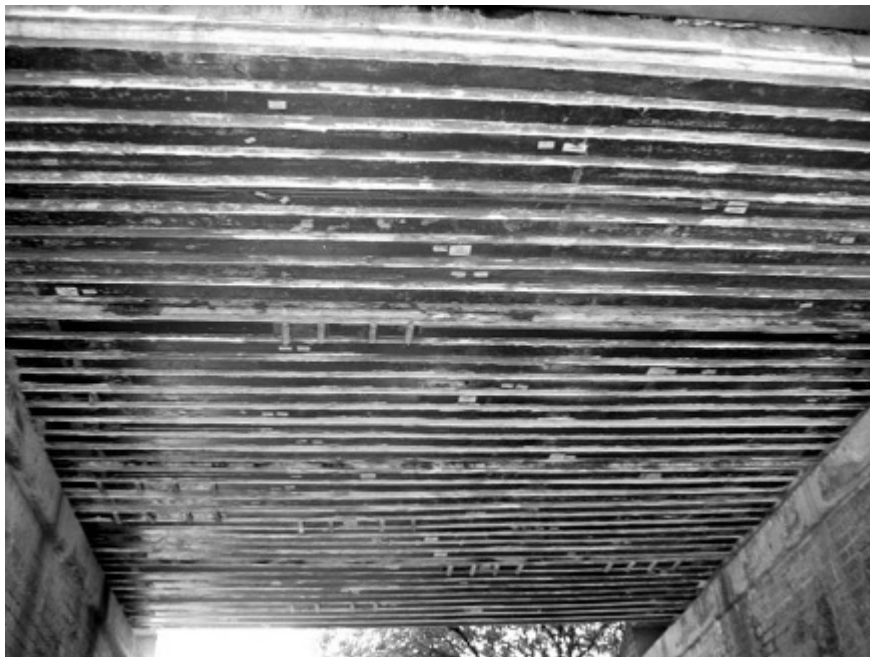
*Figure 16.13* Carbon plates applied to the soffit of the bridge.
